# New construction lido Hopfräben, Brunnen

2021

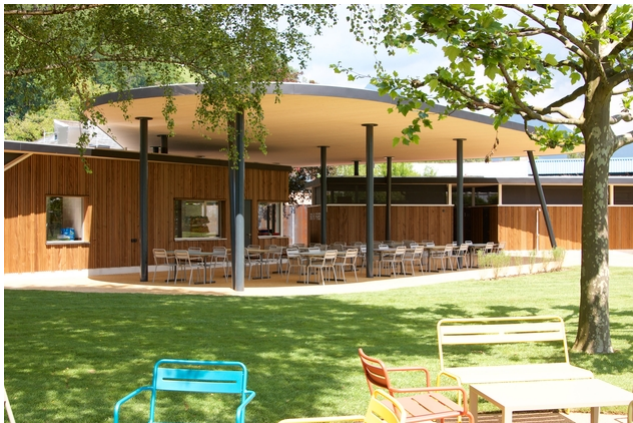
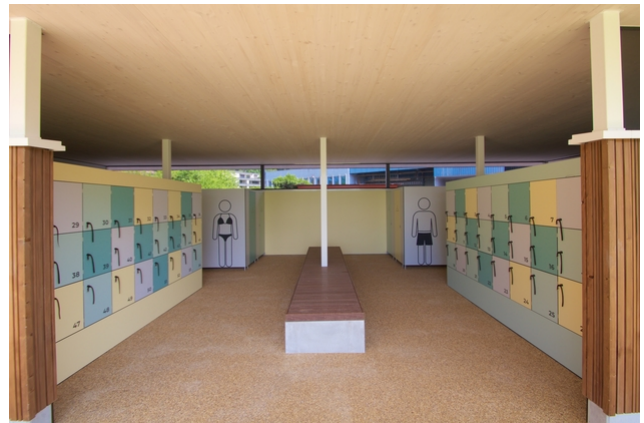
The entrance area of the Badi Brunnen was redesigned. Large-format panels made of cross-laminated timber cover the entrance area. The joint grouting on the face side with TS3 technology allows a wide column grid.

Thanks to the joint grouting on the face of the CLT panels, the roofs appear to float. The CLT panels rest on stubby columns with a grid of 8x8 meters.

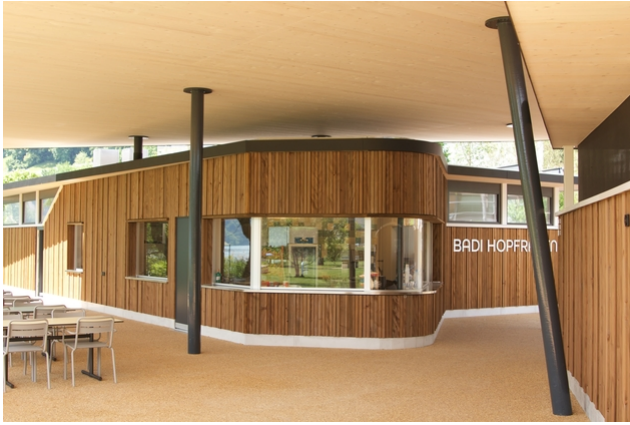
Covered bistro in the lido

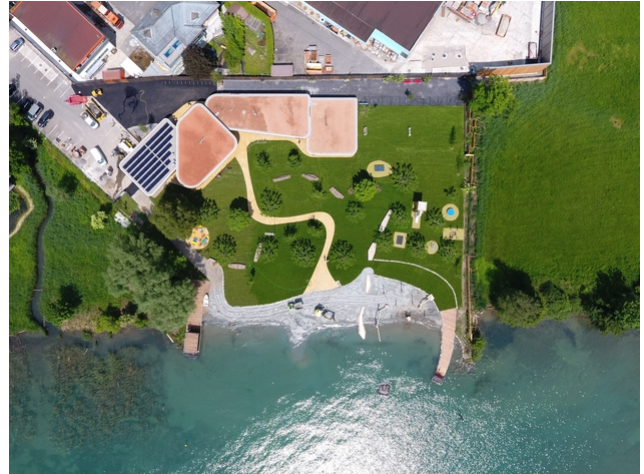
Bird's eye view of the lido
